Local Operational Research Assistance Program

2006 Annual Report

2006 Local Operational Research Assistance (OPERA) Program Annual Report

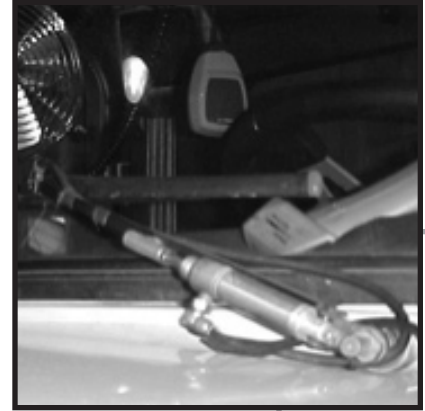
Solution Using the vehicle air system, air cylinders were mounted on the wiper arms. A button control was installed in the vehicle cab. By pushing the button, the air cylinders retract the wiper arms about 6 inches from the windshield. When the button is released, the wiper arm quickly slaps back to the windshield, driven by both the wiper arm spring and the cylinder return spring. This quick slap of the wiper arm often removes the accumulated snow and ice, making the wipers effective again and eliminating the need to stop the vehicle and climb to remove the accumulated snow and ice.

Procedure Based on the design of the wiper arms on individual vehicles, an appropriate-sized air cylinder was mounted on each wiper arm. Each wiper arm type required individual design features, including brackets, the size of the cylinder, and installation of air lines. Controls were installed in the cab in a convenient, yet out-of-the-way, location. In cases where vehicles did not have an on-board air system, an air tank was mounted on the vehicle. The air tank is charged prior to plowing and provides enough air for a typical plowing event.

Results For vehicles with bolted-down wiper arms, the system works very well, with little maintenance. It is necessary to add air-tool oil to the cylinders a couple times per year. For vehicles with quick-release wiper arms (e.g., Sterling trucks), there have been some problems. Under heavy snow conditions, operation of the device can cause strain on the wiper motor, drive arm, locking device, and wiper arm splines. Immediately after the first installations and use of these devices, vehicle operators requested these devices. The devices were installed on additional vehicles with success. The city's fleet of snow equipment is largely outfitted with these devices and operators now take them for granted as part of their equipment.

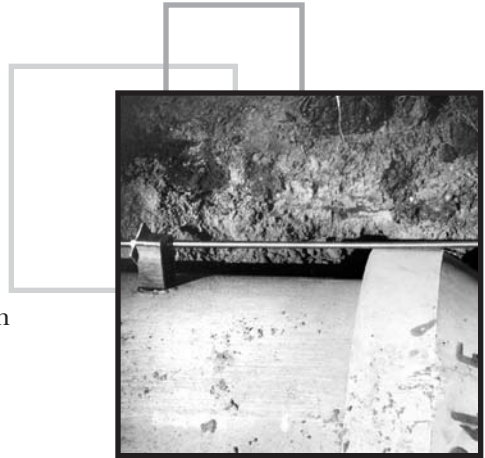
Solution Fabricate a new tie bar system that positively ties the section together from the outside of the pipe

Procedure Use a bolt and washer of sufficient diameter and length to pass through the pipe wall, inserted from the inside of the pipe and screwed into a rectangular or square section of tubing (stand-off) placed on the outside of the pipe, prior to placement in the trench. There are four stand-offs per section of pipe, except for aprons, which have two stand-offs. The stand-offs are connected by a rod, which may be a continuous or partially threaded rod with a nut on each end or a long bolt with threads on one end. At the stand-offs, integral or separate large washers and one or two nuts, depending on the type of rod used, are tightened to draw the sections tightly together for a permanent seal. The stand-offs can also be used to lift and set the pipe sections in place. Washington County maintenance fabricated 100 of these new stand-off style tie bars and tested them on concrete pipes that were being replaced.

Results The pipes tied with the new style of bars did not move or come loose, and maintenance crews found them easier to use. Holes must be drilled in the pipes prior to installation in cases when there are not holes to anchor the tie bars. Halla Industries of Sleepy Eye, Minnesota, can manufacture the tie bars at lower cost than in-house fabrication (about \$17 per tie bar, including bolts, washers, and a cadmium plating treatment).

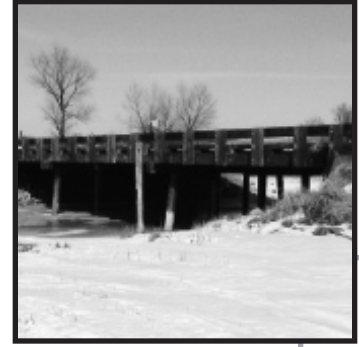
Procedure On bridge 86511 (CSAH 12 over Buffalo Creek in Marysville Township), existing mid-span spreader beams were relocated to the quarter-points of the respective spans, and then larger spreader beams were installed at the center point of the spans, as well as a spreader beam at the other quarter-point of each span. The bridge was resurfaced and crack control joints were sawed at each support.

Results Increasing the number and size of spreader beams increased bridge capacity and performance, resulting in an inventory rating increase.

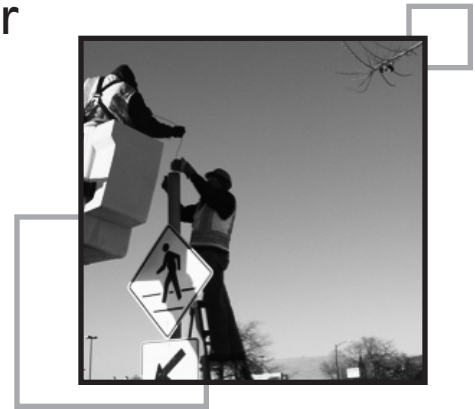
Solution Install and evaluate a solar-powered, wireless pedestrian-activated flasher system (Carmanah R820 solar-powered LED beacon). The two units on both sides of Rice Street and one in the center median coordinate via a wireless radio frequency transmitter. The intensity of the LED flasher peaks at 800 candela in daylight and 400 candela at night. The flashing rate is between 50 and 60 flashes per minute in a “bouncing ball” effect. It can operate at least 30 days between solar charges. The manufacturer’s recommended maintenance is every five years (except for rechargeable battery pack replacement).

Procedure The system was installed in St. Paul at an east-west pedestrian crosswalk on Rice Street, south of University Avenue: one flasher on each side of the street and one in the median. The system flashers are activated by a push button on either end of the crosswalk. Mn/DOT then collected crossing data, including traffic speeds and stopping rates, push-button use rates, and surveys.

Results Based on the observation data, the maximum pedestrian queue was reduced after the flasher installation for both the transition phase and the after-study phase. As a result, conflict points at the crosswalk were reduced. Pedestrian flashers have impacts on driver reactions immediately (within two weeks) after the device’s installation. However, three months later, the percentage of vehicles stopping for pedestrians returned to levels similar to those prior to the flasher installation. Flashers seem to have a very short-term impact on vehicular stopping actions. Based on the observation, pedestrian safety education is highly recommended, including device and safe-crossing education. Use a confirmation light to communicate with the pedestrian when the push button has activated the flashers. Flash timing can be shortened (this project’s timing was 30 seconds). Additional signage could help to clarify how to use flashers.

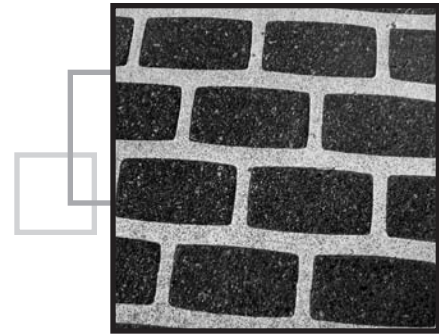
Solution DuraTherm is a preformed thermoplastic pavement marking for crosswalks, inlaid into bituminous pavement. It can be installed in several decorative designs, including an offset brick pattern. The purpose of this test was to investigate the installation methods, impacts to pavement surface, durability, retro-reflectivity, wear, and cost.

DuraTherm was installed by impressing a pattern template into the bituminous pavement using a StreetHeat SR-60 pavement reheater, preventing the bituminous from overheating. The DuraTherm thermoplastic material was then placed into the inlay and heated to melt into the pavement. The installation process runs smoothly with little mess. Similar to other materials, DuraTherm installation may be done in sections, allowing the intersection to remain open to traffic. The installation time is much longer than that of other materials: all three legs of the intersection required about eight hours to complete. Weather conditions have effects on installation similar to other materials. The impacts of the installation on the bituminous pavement were minimal. The heating of the template and material left a clean, tight fit in the bituminous pavement.

Results Ramsey County added DuraTherm as an option on its list of pavement marking materials. While the high cost makes it prohibitive as a choice for installation at most intersections, the aesthetic abilities make it a good choice in specialty situations: part of a larger streetscape project to provide a different look. The markings were in good condition after a one-year period consisting of a full maintenance cycle (including snowplowing). The color remains bright white and the crosswalks have maintained their reflectivity. The pavement surface was not measurably impacted after the installation of the markings. After a year, the pavement was still in good shape, without chipped or deteriorated edges or loose joints between the bituminous and DuraTherm marking. Agencies should determine whether the brick pattern in this test case meets the definition of a crosswalk per the *Minnesota Manual on Uniform Traffic Control Devices*, as more and more agencies are looking to use pavement markings as part of their larger streetscaping projects. Also, the longevity of DuraTherm must be compared to less-expensive options, such as epoxy crosswalks. Ramsey County's experience with epoxy crosswalks assumes a three-year lifespan at a signalized intersection. The DuraTherm markings, with a cost of five times that of epoxy, would need to last significantly longer.
