# OPERA

Local Operational Research Assistance Program

## 2011 Local Operational Research Assistance (OPERA) Program Annual Report

## 2011 ANNUAL REPORT

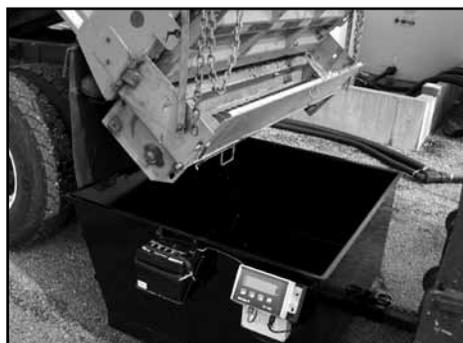
**Solution** Olmsted County used a Scale-Tec Calibrator IV to correctly calibrate the amount of salt and sand being applied by each truck. The device measures the spread of the material to an exacting level of 99.5 percent.

**Procedure** The county used the Scale-Tec Calibrator on each of its Force America 5100 spreaders. The spreader was set to scale mode, and the calibrator was placed under the spreader discharge. The dump body of the vehicle was raised, the auger filled, and the spreader turned on to allow the salt and sand material to fall into the scale. By measuring the weight of the material, the calibrator helped the county determine the appropriate settings for each spreader to ensure the correct and consistent application of salt and sand.

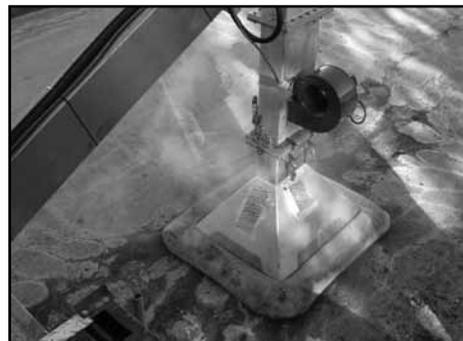
**Procedure** Cold-weather field testing was completed at NRRI and select locations in Anoka County and St. Louis County using a portable microwave unit provided by Microwave Utilities Inc. Crews first preheated the pothole to melt any ice or snow and soften the pavement. Then, the mixture of RAP/millings, taconite materials, and RAS was placed in the pothole and heated to at least 230 degrees Fahrenheit using the mobile microwave equipment. Heating took an average of 8 to 12 minutes. A portable compactor was then used to compact the heated mixture.

**Results** RAP/millings that were minimally contaminated with sand and gravel worked best. The taconite materials significantly enhanced microwave absorption, and the RAS enhanced the binding characteristics of RAP. The microwave equipment quickly heated and softened the pavement surrounding the pothole, which was critical for providing a good bond and repair.

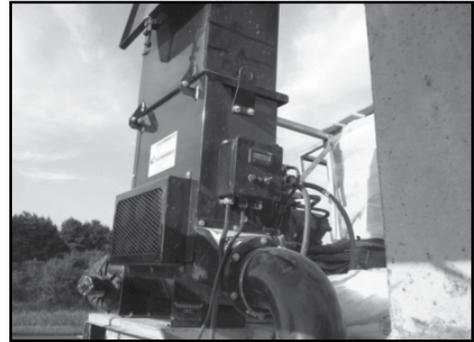
**Procedure** The flexible microsurfacing system consists of an emulsion formulation enhanced with a performance additive. The Texas Overlay Test was used in the lab mix design to assure that better crack-resistant properties could be achieved with the new material. The microsurfacing product was then used on County State Aid Highways (CSAH) 18 and 37 in Wright County, both of which were experiencing slight rutting. Traditional microsurfacing was placed on the majority of each roadway, with a 1,500-foot section of flexible microsurfacing placed for comparison and evaluation on each road.

**Results** There was some construction difficulty with the flexible microsurfacing on CSAH 37, mostly associated with retarder pump and pugmill performance issues that affected the cure of the product. Surface treatment blemishes caused by the equipment problems were fixed by the contractor. Also, the performance additive sporadically clogged the additive machine. A shorter fiber additive was used, and the problem was eliminated.

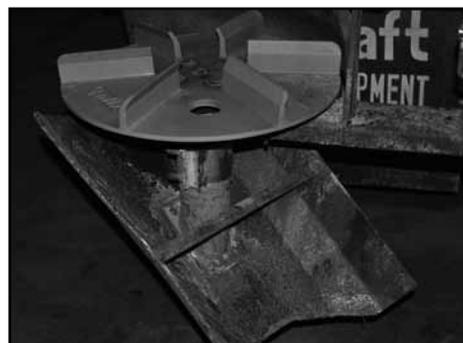
**Solution** Washington County fabricated a simple salter/sander chute that can be installed below a vehicle's spinner, allowing the spinner to disperse deicing material when necessary. An accompanying CAD drawing was created to allow other agencies to easily fabricate, install, and adjust the salter/sander chute.

**Procedure** Three chute designs were fabricated, and the chute identified as the easiest to install and adjust was chosen for the CAD drawing. The selected design is attached to the spinner motor with a clamp and can be adjusted to deliver material at different angles depending on the type of roads on a given route. The chute also remains centered under the spinner even when pivoted, ensuring that all material coming off the spinner falls into the chute.

**Results** The design was attached to one truck for the winter of 2010–11. The driver reported more accurate material placement and minimal loss of material off the road, with an estimated 25 percent less material used on the route. The Minnesota Department of Transportation also conducted extensive testing on the chute, and results indicate excellent performance at speeds between 20 and 30 miles per hour. The chute allows deicing material to be placed on the road without the loss of material commonly caused by higher forward speed.

No wear edge was installed on the chute, which caused two to three inches of the plastic to wear away where the chute came in contact with the pavement. A wear edge made of heavy rubber could be bolted to the bottom of the chute and replaced as needed to increase the overall life of the chute.

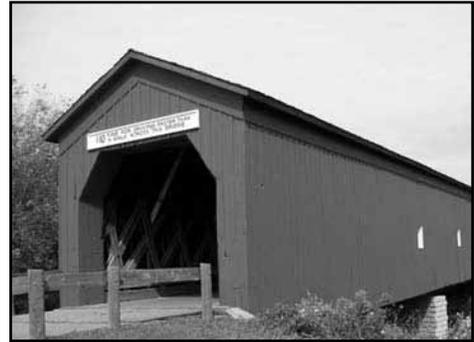
**Solution** The City of Zumbrota contracted with the University of Minnesota Duluth's Natural Resources Research Institute (UMD NRRI) to complete three-dimensional scanning and data processing of the Zumbrota Covered Bridge, the only remaining historic covered bridge in Minnesota. Constructed in 1869 and relocated several times, the bridge now spans the Zumbro River in a city park. The UMD NRRI had previously partnered with the U.S. Forest Service to conduct similar scanning of historic covered bridges in Wisconsin and Iowa.

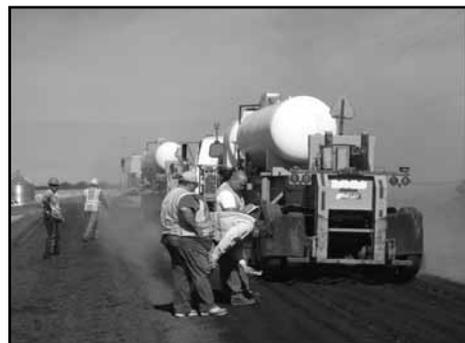
**Solution** Blue Earth County completed a gravel road stabilization project on a section of County State Aid Highway (CSAH) 48 using a blend of recycled asphalt shingles (RAS) and recycled asphalt pavement (RAP) rather than the typical stabilizing binder used in past projects. This mix required almost a third less asphalt emulsion than bituminous stabilized gravel roads.

**Procedure** In partnership with Waste Management and Road Science, Blue Earth County applied a mix of 65 percent RAP, 15 percent RAS, 18 percent gravel, and 2 percent asphalt emulsion on a 1-mile segment of CSAH 48. County maintenance crews spread the RAP and RAS on the roadway surface and used a reclaiming machine to mix the two together. They then injected the asphalt emulsion before compacting and blading the surface.

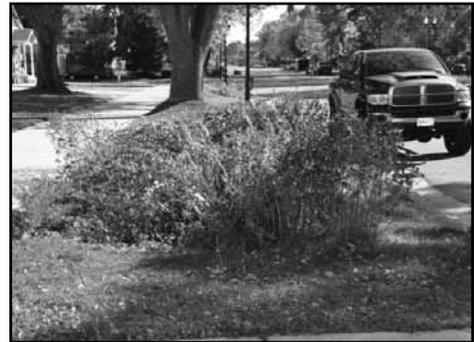
**Solution** The City of Grand Rapids began constructing modified rain gardens as part of a 2008 street reconstruction project on First Avenue Northwest. Since the rain gardens are not large enough to be used solely as infiltration basins, they are connected and allowed to discharge to the city's storm sewer system.

**Procedure** The gardens were constructed between the curb and the sidewalk on First Avenue Northwest. Each garden is about 15 feet wide and 25 feet long, with a total size of 375 square feet. The rain garden design includes an infiltration pipe and an overflow pipe, allowing the rain gardens to discharge excess water to the storm sewer system.

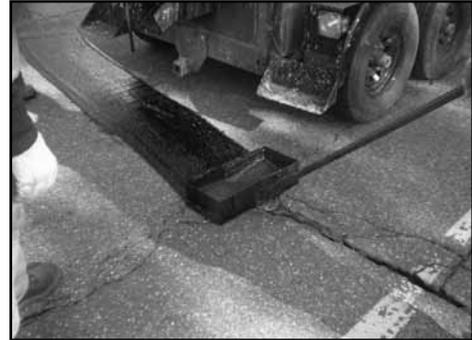
**Solution** The City of Bloomington partnered with the City of Minnetonka to compare the performance of mastic products to that of traditional bituminous patching. In spring 2011, the cities collaborated on a field investigation of the installation and performance of two mastic patching materials along with standard patches that were applied at the same time.

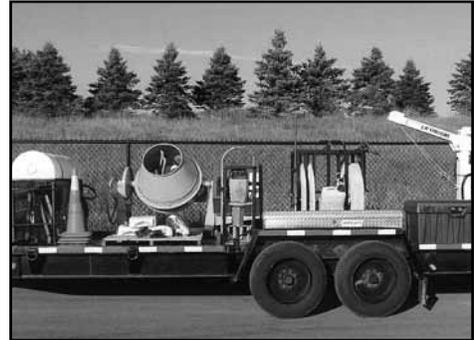
**Solution** An existing 15,000-pound trailer was designed specifically for catch basin repairs and maintenance. All of the necessary equipment and materials are always readily available on the trailer when projects arise.

**Procedure** The city fitted an existing trailer with all of the equipment needed for catch basin repairs. The city had a service crane installed on the rear curb side of the trailer for easy access to the catch basin manhole, and it also purchased a cement mixer, water tank, and storage container for use on the trailer. City staff fabricated the steel and placed all equipment on the trailer.

The City of Lakeville completed an OPERA-funded project intended to reduce costs and improve efficiency related to catch basin repair operations. The city created a specialized trailer outfitted with a service crane, cement mixer, water tank, storage containers, and other tools needed for the rehabilitation of storm sewer structures and catch basins.

“The OPERA Program made it possible for us to fabricate, purchase equipment, and complete the catch basin repair trailer... Now our crews have everything they need,” Grossman said, which saves staff time on both ends of a project. The trailer also allows for improved safety, with much of the equipment installed on the curb side of the trailer to keep crews out of the traffic lane whenever possible.

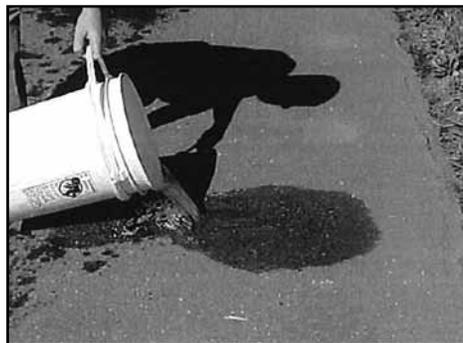
**Solution** The City of Hutchinson used Replay®, an agricultural oil seal and preservation agent that contains no petroleum. It penetrates over 1 inch into the pavement surface, and polymers bond the top layer of asphalt together to seal the surface. It takes about 30 minutes to dry before traffic can resume use of the pavement.

**Procedure** The city applied the material with a truck-mounted sprayer after removing debris from the pavement surface. The city chose two test sections with different pavement conditions: an old trail with raveling and cracking and a relatively new driveway with only minor deterioration. The pavement was dry to the touch within 30 minutes after the application, and the material did not track onto other surfaces or stick to shoes or clothing. To evaluate the effectiveness of the material, the city poured water onto each asphalt surface before and after Replay® was applied.
