Cement Stabilized Base & Chipseal County Road 54... The Saga Continues

MCEA Annual Conference January 23, 2020

John Brunkhorst, PE - McLeod County Engineer/PW Director Dave Rettner, PE - American Engineering Testing Inc.

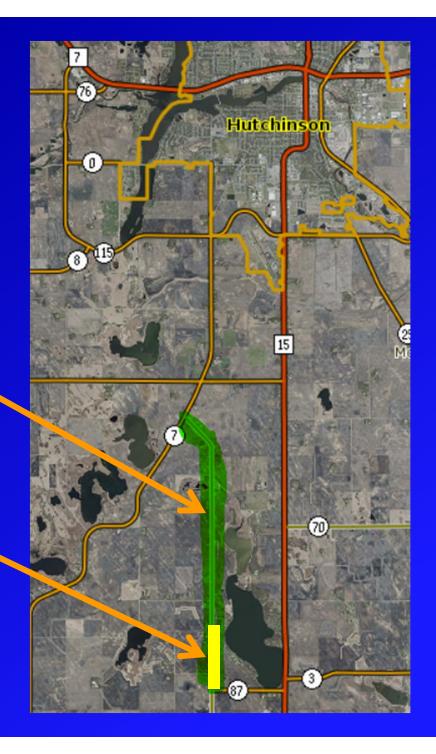
Where is Project?

County Road 54 (CR 54)

~ 6 miles South of Hutchinson, MN

Entire Corridor
~4 miles
CR 87 to CSAH 7

Initial Project ~1 mile

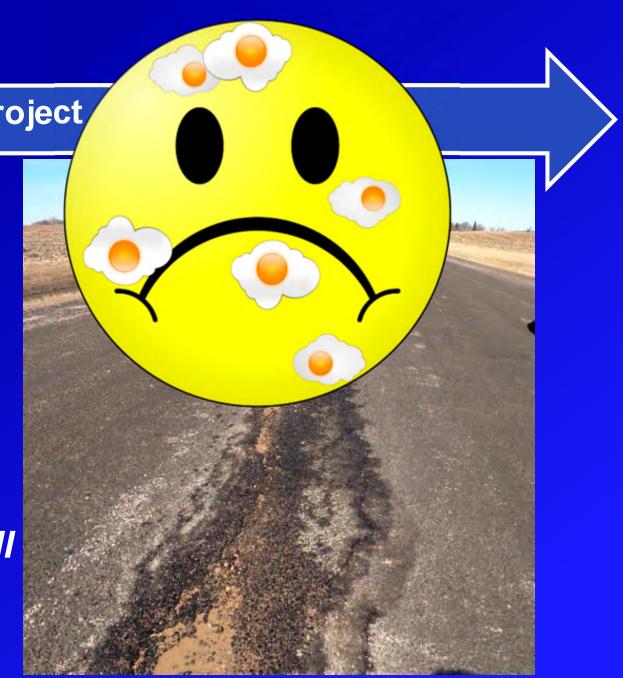
2014 Prime/Seal Project

Emulsified Prime Coat

- Single Chip Seal
- Fog

Portions began to break up in fall

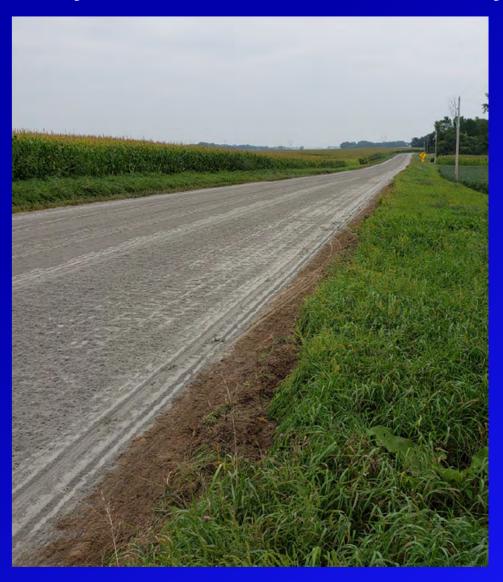
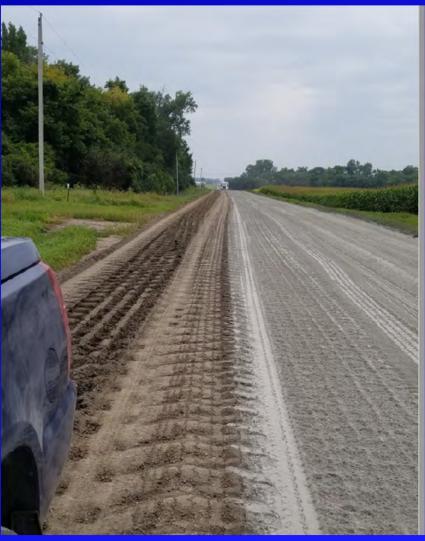
Early Concerns with Cement Laydown

- It Appears that the Time Between the Start of Mixing and Final Compaction was too Long. Stretches Being Worked were too Long to be Completed in One Hour.
- Divots in Road Surface were from Poorly Compacted Material Filling Padfoot Roller Depressions – Related to Time to Finish
- Variability in Strength both at Surface and at Depth Possibly Due to too Much Time from Start of Mixing Until Final Compaction
- Design Strength was Achieved in Many Locations
- Often only 6 inches of Stabilization Met Strength
- Dirty Surface of Roadway After Micro-milling Might have Hurt Bonding of Chipseal

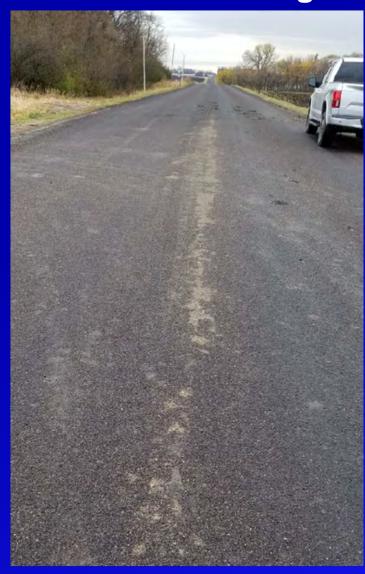
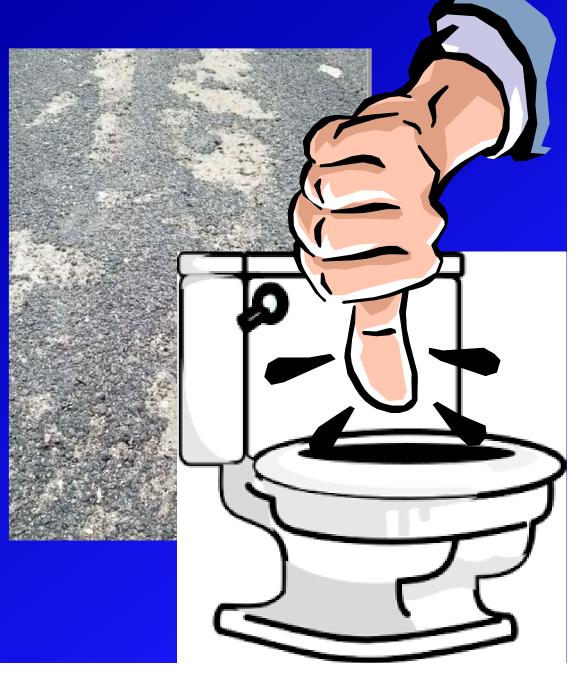
Sealcoat Debonding

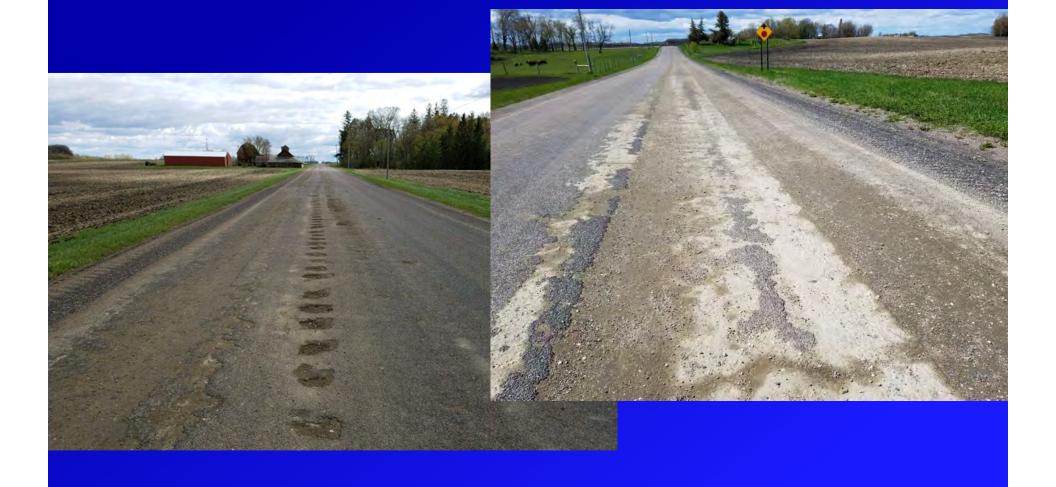
Chipseal Continued Debonding over the Winter/Spring

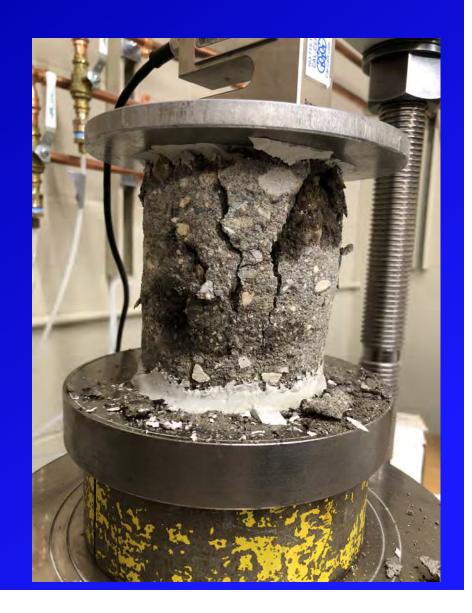
Cores that were Removed Intact were at or Near Design Strength (250 psi)

Core	UCS (psi)		
C-1	274		
C-3	193		
C-4	158		
C-5	98		
C-7	297		
C-8	338		
C-9	225
