Ultra Guard Cart Test

Washington County Public Work

December 9, 2010
Project #2009-10

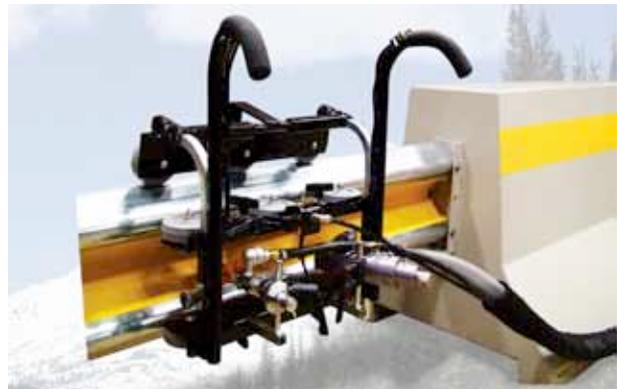
One solution to provide more durable and continuous delineation to guard rails, jersey barriers and concrete bridges is to use the Ultra Guard Cart to delineate horizontal curves. The added reflectivity can assist drivers through curves and help prevent automotive collisions with barriers.

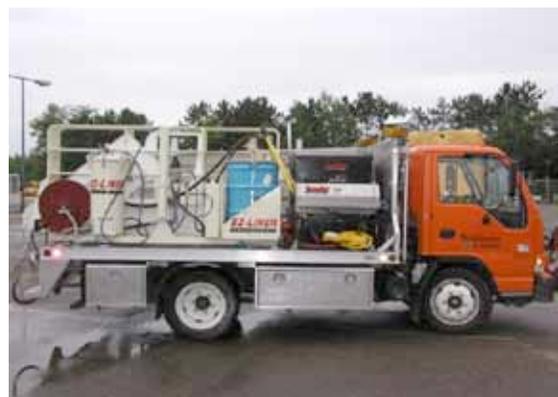
After receiving the Ultra Guard Cart our mechanic spent 3 hours hooking it up to our pavement message unit. It was a reasonably simple job because we have an EZ-Liner AL 110 palletized message unit, which has the

paint, beads and compressed air needed to operate the Ultra Guard cart unit. Only

minor modification was needed to make the unit attach and remove easily to make the message unit usable again.

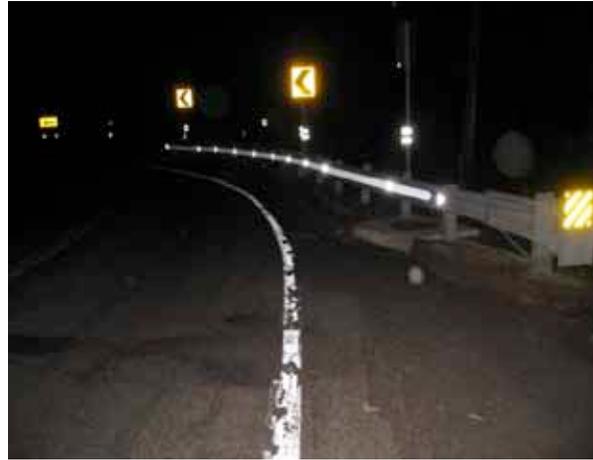
simple to adjust for different types of barriers. We painted our guard rail with white Diamond Vogel latex paint using AASTO Type 1 MR 80% MIN beads. We have done numerous night surveys at each of the locations. What we have noticed is the stripes applied to locations

with gradual curves are not as noticeable as the locations with the more severe turns.

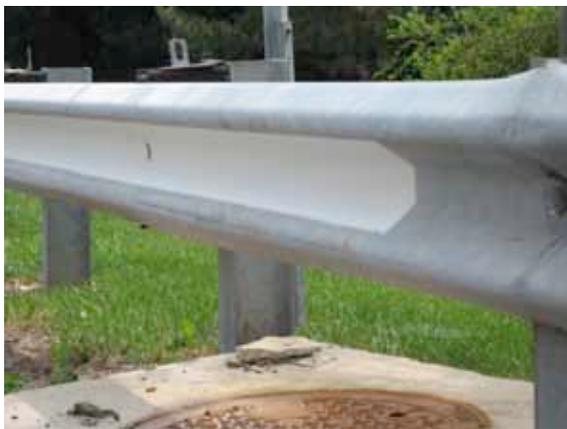
The paint applied to the guard rail using the Ultra Guard cart does not reflect as brightly as the delineators; however the Ultra Guard line is continuous and is not as vulnerable to snow plow damage like the road paint.
