OPERA
Local Operational Research
Assistance Program

2008 Annual Report

2008 Local Operational Research Assistance (OPERA) Program Annual Report

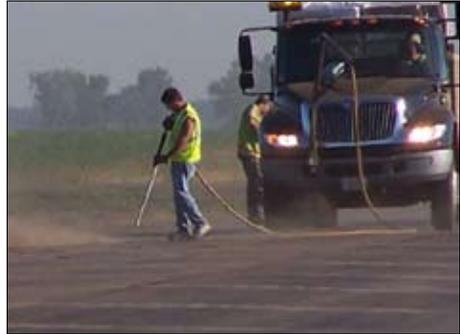
Project Number	2005-02	
Project Leader	Courtney C. Kleven	
Agency	Red Lake County Highway Department 204 7th Street SE Red Lake Falls, MN 56750	
Phone	218-253-2697	
Problem	Existing bituminous pavements require major seasonal maintenance for both thermal and distress crack repairs. Less expensive alternatives are needed to isolate existing structural and cracking problems and retain strength and usability of existing roadways.	
Solution	Use spun-glass paving fabric to preserve existing bituminous pavements by isolating the effects of heavy crack sealants and reflective cracking. Paving fabric may isolate overlay pavements from current cracking and moisture intrusion paths, allow retention of base and bituminous for route upgrades, and reduce the need for and impact of future crack treatments.	
Procedure	Spun-glass paving fabric was installed on 300-foot sections in 14 areas. For comparison purposes, the preceding and succeeding 300 feet adjacent to the test segments were also documented and evaluated.

Results	Inspections concluded that the installation of the spun-glass paving fabric did not add structural strength or retard early thermal and centerline cracking. The fabric can be installed at less expense than mill, however, and can be installed over existing pavement or over fresh blade-laid leveling course.	
Approximate Cost	\$10,000 (\$10,000 approved for project)	
Implementation	Evaluation of fabric effects on cracking should be continued until better data is demonstrated.	
Status	Completed.

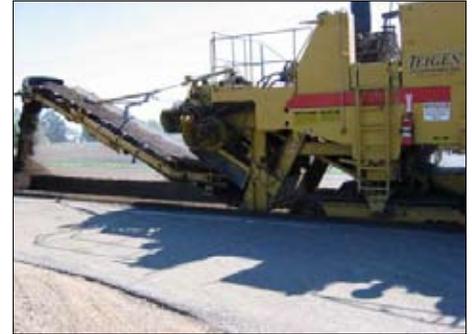
Procedure The county line road shared by Dodge and Goodhue Counties was reclaimed to a depth that includes the asphalt and some base. About 660 gallons of Base One was mixed with water and blended with about 2 miles of reclaimed materials in windrows. The remaining section was reclaimed without the solution. Just prior to paving, the project site received heavy rain, which delayed paving of the stabilized section for a month due to excessive moisture.

Results A visual inspection of the test section and control section showed no noticeable difference. Both sections are performing well. Non-destructive falling-weight deflectometer (FWD) testing determined that no benefit was achieved by adding the base-stabilizing agent to 5.5 inches of reclaimed bituminous.

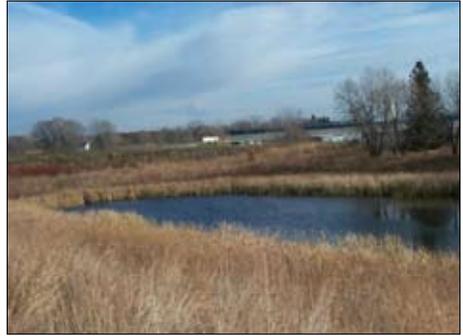
Project Number	2006-07	
Project Leader	Tom Tri	
Agency	St. Louis County Public Works 4787 Midway Road Duluth, MN 55811	
Phone	218-625-3876	
Problem	The Minnesota Pollution Control Agency requires public road authorities and others to construct storm-water ponds as part of its National Pollutant Discharge Elimination System (NPDES) permit. Many of the storm-water ponds detain runoff for long periods of time and later discharge the water to protected and or impaired waters of the state. With longer detention periods, the storm water may undergo deterioration of water quality in terms of dissolved oxygen and temperature.	
Solution	Install two windmills to aerate the large pond. This method uses wind energy at no cost and a direct drive compressor to provide the air flow/oxygen necessary to aerate the pond.	
Procedure	Two 23-foot windmills were easily assembled and installed on a berm adjacent to the large pond for optimum wind conditions. Dissolved oxygen (DO) and temperature levels were measured several times during winter 2005 and throughout of 2006 and 2007.

Results	Overall turbidity has declined to less than 10 NTU's (almost clear water) since the windmills were installed.	
Approximate Cost	\$3,175	
Implementation	The county will continue to aerate the storm-water pond as it appears to have an overall beneficial effect. In addition to treating storm water, the ponds have attracted wildlife.	
Status	Completed

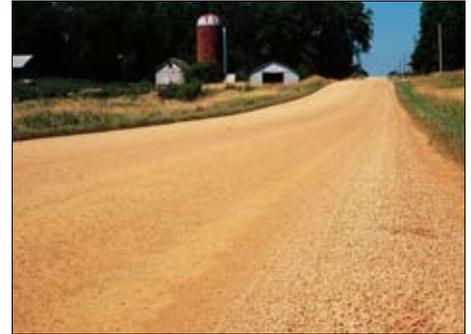
Project Title	Seal Coating of a Gravel Road Hill
Project Number	2007-01
Project Leader	Elvin Paulson
Agency	Yucatan Township 9383 Cut Across Road Houston, MN 55943
Phone	507-864-7623
Problem	The grade and curves on the Muhle Coulee Hill create a problem for keeping the surface smooth. Trucks and trailers have difficulty keeping up speed and reaching the top of the hill.
Solution	Put seal coating on the top 1/2 mile of Muhle Coulee Hill.
Procedure	Yucatan Township contracted Knife River to apply the seal coating. Gravel was applied and then graded, and hot oil and chips were put down and rolled to a smooth surface.
Results	There is now a smooth surface on top of the hill. The road was heavily used during an August 2007 flood, and the seal coating remained solid.
Approximate Cost	\$38,000 (\$10,000 approved for project)
Implementation	The seal coating will continue to be used as a solution to this problem.

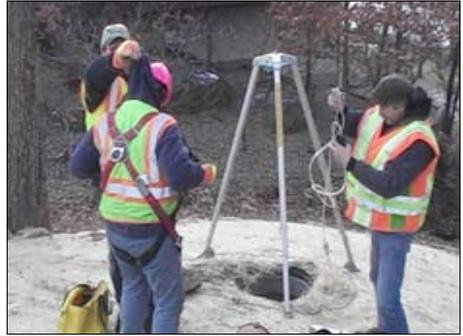
Project Number	2007-02	
Project Leader	Terry Noonan	
Agency	Ramsey County Public Works Department 1425 Paul Kirkwold Drive Arden Hills, MN 55112	
Phone	651-226-7160	
Problem	The implementation of the National Pollutant Discharge Elimination System (NPDES) Municipal Separate Storm Sewer System (MS4) Permit requires that owners of MS4 storm sewer systems inspect the systems for maintenance needs. The inspections are time consuming and require special training and equipment.	
Solution	The QuickView camera system allows a single person to view the sewer system, with setup, in less than 10 minutes. QuickView allows the inspector to take still images and record them on a memory card as well as video/audio recorded on a DVR tape. The camera also measures distance.	
Procedure	The camera was used in several structures, including short corrugated culverts, long concrete storm sewers, sanitary pipe, shallow and deep manholes, and outlets and inlets, both with and without water.

Results	Ramsey County found the camera to be efficient and easy-to-use. The camera saves time as well as eliminates the dangers associated with the confined space entry. QuickView provides a warranty on the system, and assistance is easily obtained.	
Approximate Cost	\$16,000-17,000 (\$10,000 approved for project)	
Implementation	The City of St. Paul has purchased a number of the cameras to be used for sewer inspection.	
Status	Completed

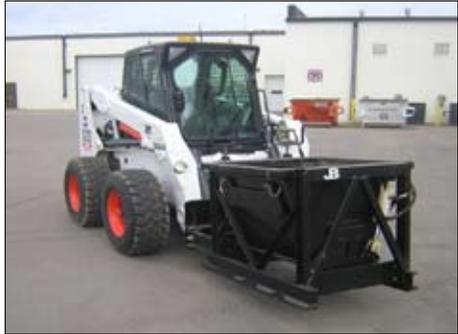
Project Number	2007-04	
Project Leader	Jay Johnson	
Agency	City of Cottage Grove 8635 West Point Douglas Road South Cottage Grove, MN 55016	
Phone	651-458-6080	
Problem	Longitudinal cracks develop along curb lines and centerline streams, forcing crews to hand-patch certain areas in order to preserve the integrity of the bituminous surface. This presents a number of problems. Hand-patching does not stay in place through the freeze/thaw cycle, nor does it uniformly seal the joints. The drive quality of the road is also reduced by hand-patching.	
Solution	Use the Mini Paver to repair roadway instead of hand-patching.	
Procedure	The Mini Paver was tested under four different applications including skin-patching along the concrete curb line, overlay application along curb line, centerline or crown area paving, and gravel shouldering.	
Results	Using the Mini Paver more than doubles the amount of patching that can be completed in a day. There will be a uniform, neat patch, and roads will remain in better condition longer, increasing the life expectancy of the road.

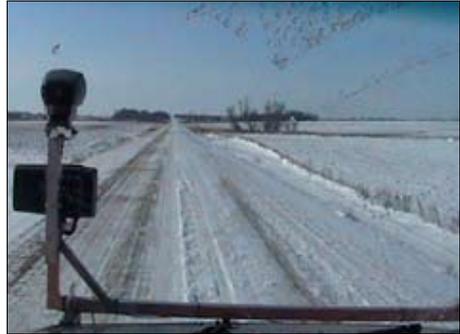
Project Number	2007-09	
Project Leader	Gary Haugen	
Agency	Big Stone County Highway Department 437 Minnesota Street North Ortonville, MN 56278	
Phone	320-839-3747	
Problem	Windshield wipers become coated with ice during snowplow operations, causing poor visibility out of the windshield. The ice coating can also damage the windshield when tiny rocks get embedded into the ice and scratch the glass.	
Solution	Use Hot Beam heated wiper blades on snowplow trucks to keep ice from forming.	
Procedure	The Hot Beam wiper blades were installed on the front of a 143H motor grader and also on a 1999 Sterling tandem.	
Results	The heated wiper blades performed well compared to the standard blades. Drivers had no problems with ice sticking to blades or the windshield. The blades performed especially well when plowing in a direction where the wind brought a large amount of snow up over the windshield.
